**Motion 12950**

1                   A MOTION declaring an emergency and extending a  
2                   waiver from competitive bidding and solicitation  
3                   requirements for the King County Norm Maleng Regional  
4                   Justice Center hot water piping system replacement project.

## **Norm Maleng Regional Justice Center - Kent**

### **Heating Piping Assessment Final Report**

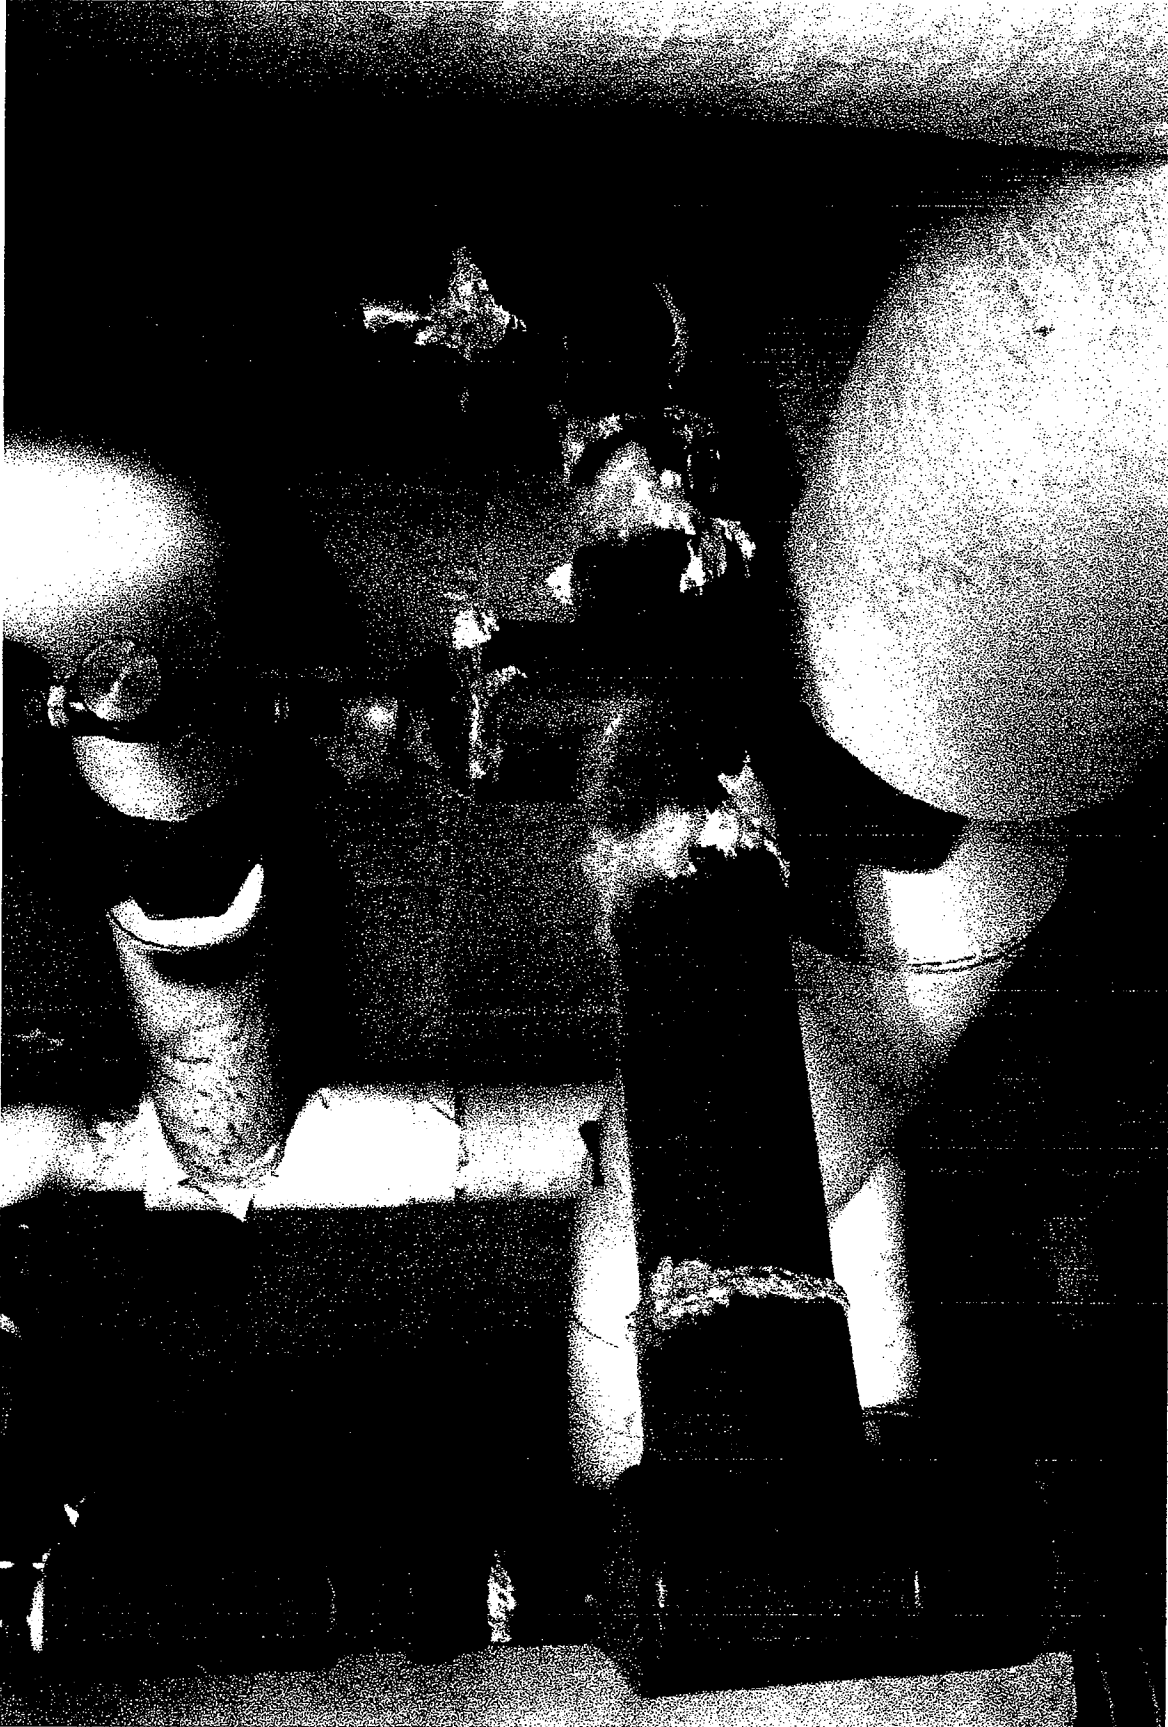
P-2 Pipe At Water Heater  
Crystalline substance is a salt-like structure. Fuzzy material is leftover fiberglass insulation.

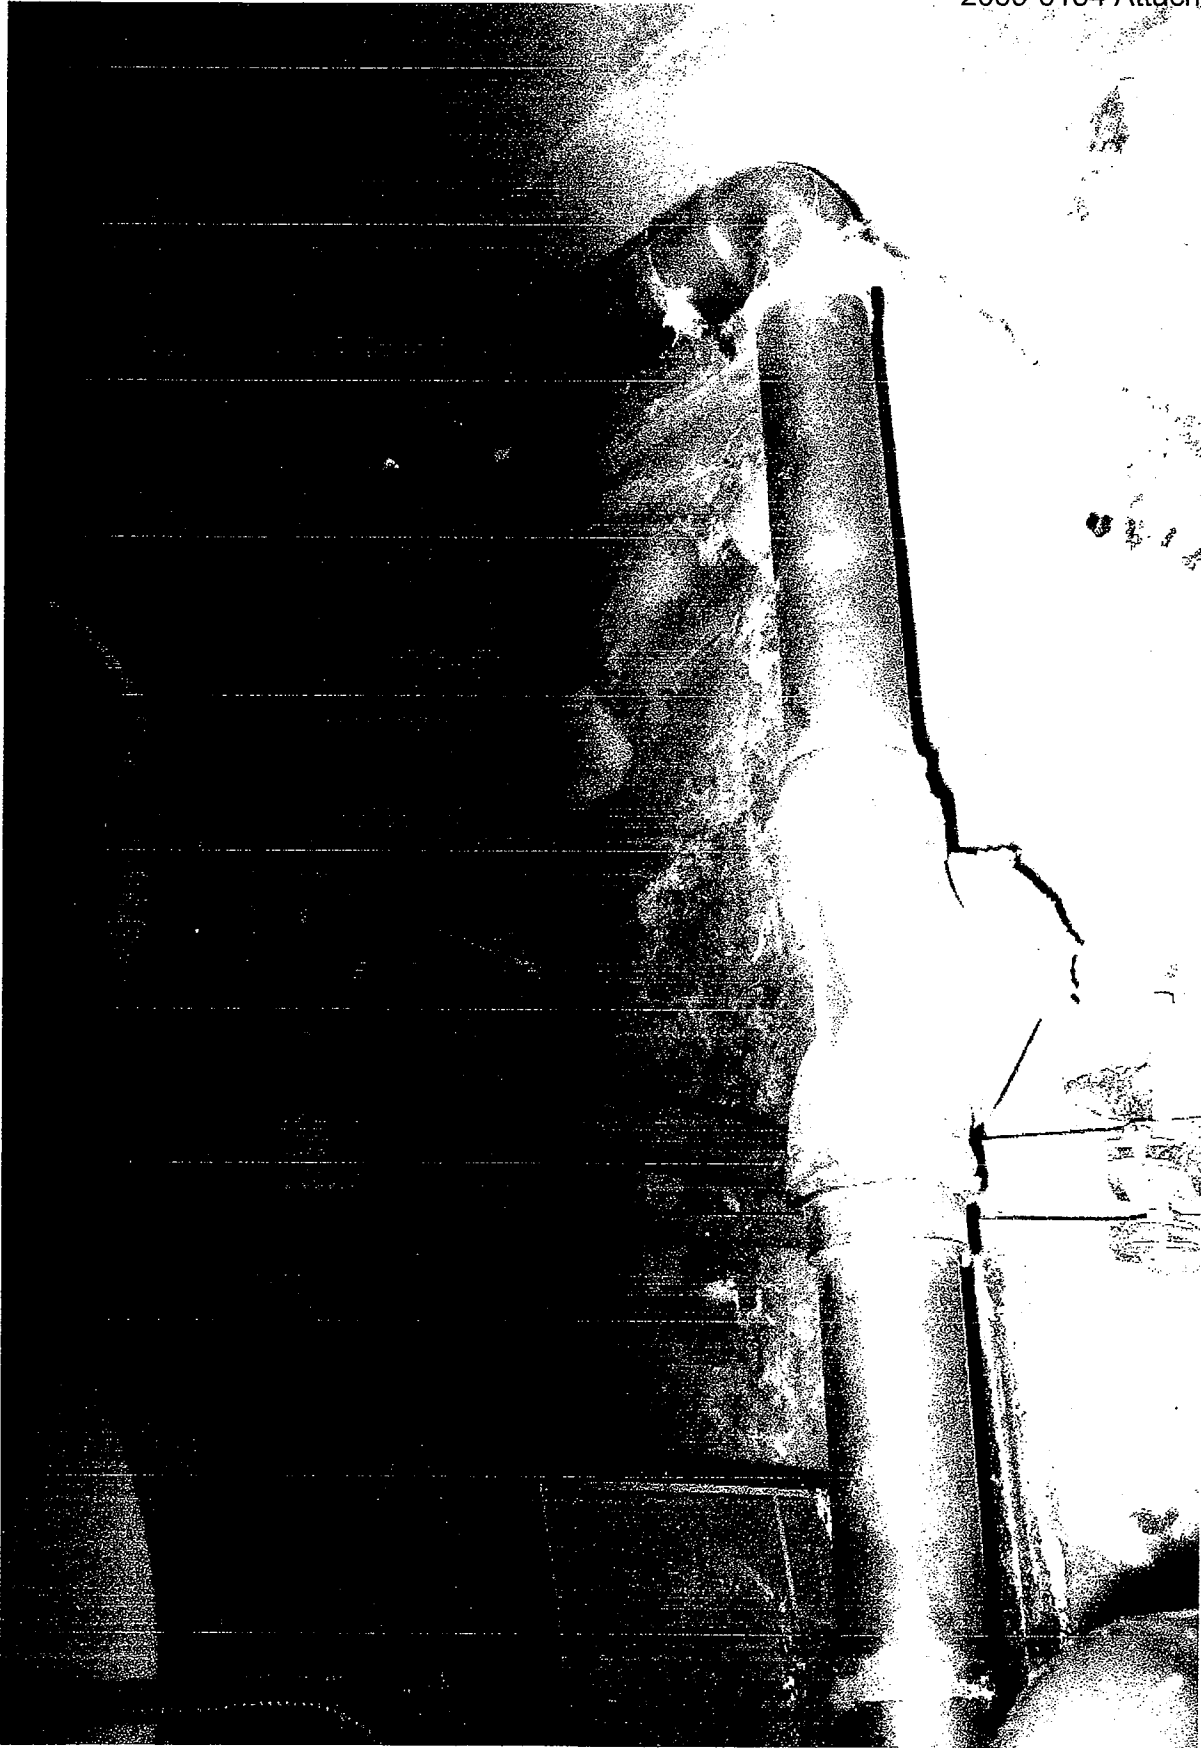
P-7 Pipe  
Typical field photo at a water heater.
