## Signature Report

### Motion 15693

1           A MOTION acknowledging receipt of a report providing  
2           information and analysis regarding the design and  
3           placement of Section 2 of the Kenmore interceptor and the  
4           impacts thereof on sedimentation and fish populations as  
5           required by the 2019-2020 Biennial Budget Ordinance,  
6           Ordinance 18835, Section 108, Proviso P2.

Kenmore Interceptor Proviso P2 Support

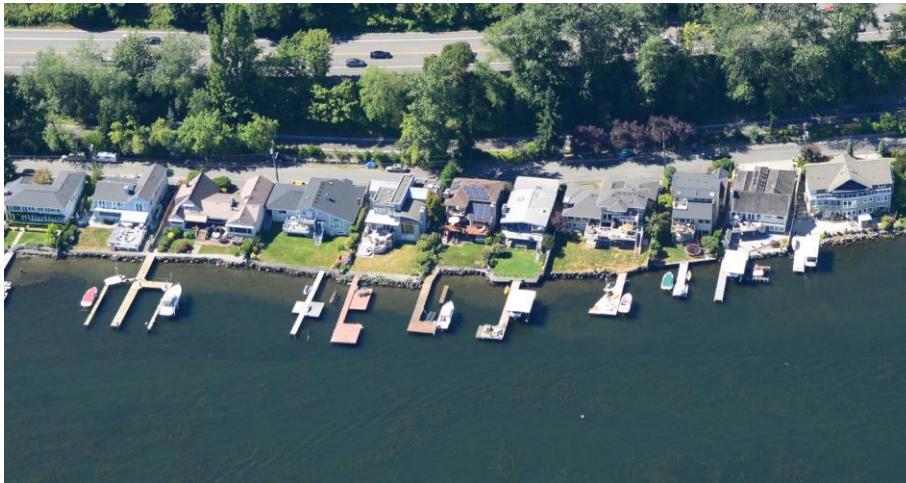
**Figure 3**  
Study Area Typical Shoreline Condition

Today, shoreline conditions along Sheridan Beach and Beach Drive NE generally consist of managed grass lawns, few to no trees or other overhanging vegetation, docks (which vary in length from 50 feet to 375 feet), and small overwater structures such as boat houses. Nearly every property adjacent to the shore has a private dock. In total, 56 docks span the 4,700 feet of shoreline in the study area, which corresponds to a dock density of one structure per 80 feet. The shoreline is also heavily armored by revetments and bulkhead walls, occasionally punctuated by managed sandy pocket beaches. Figure 3 shows the typical shoreline conditions along Beach Drive NE.

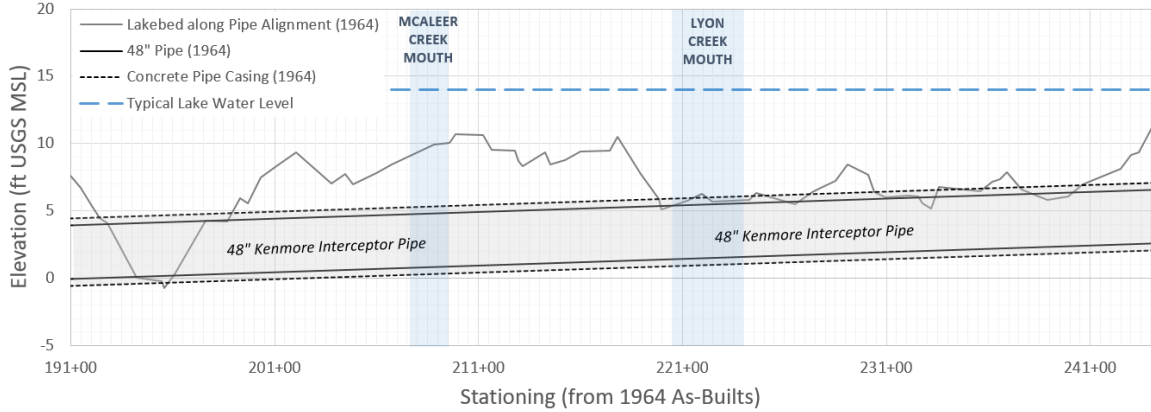
**Figure 4**  
Typical Section of Kenmore Interceptor Lake Line

The 1964 plans indicate that a stretch of the pipeline at the southern end of the study area appears to be installed in a depression or trench. It is unclear if the pipe was backfilled following installation in this low area. This stretch is about 500 feet in length and is located in deeper water where the pipeline is farthest from shore.

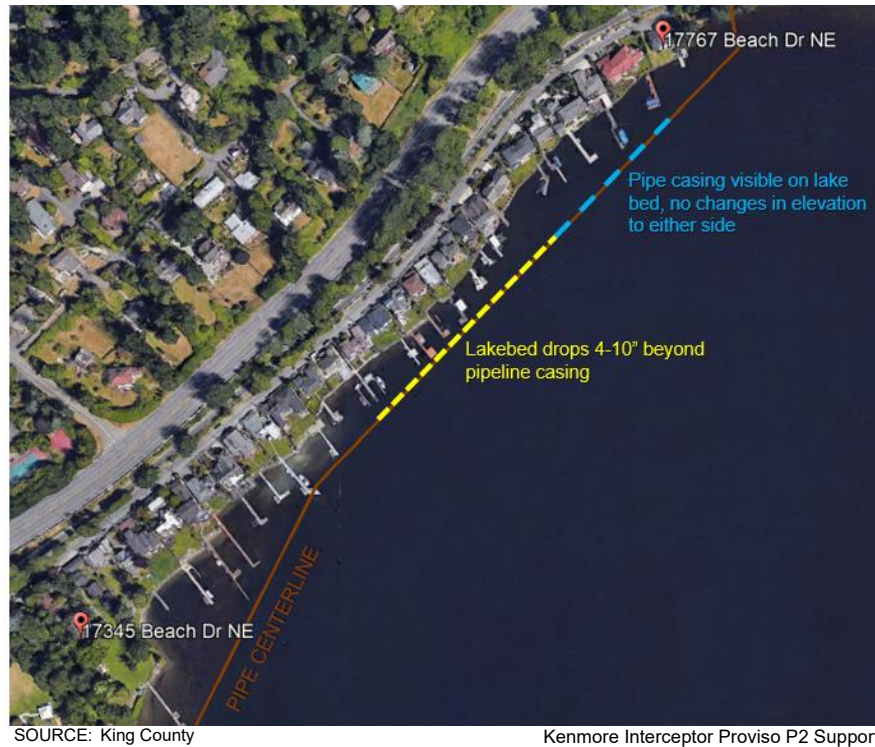
**Figure 15**  
ROV Inspection Observations  
King County Environmental Lab – Oct. 2, 2019

The conditions observed during the ROV survey are somewhat different than the previous observations from 2011. While the 2011 survey observed an approximate 10-foot stretch of pipeline with a drop to the offshore side, the 2019 ROV inspection appears to show a roughly 500-foot stretch with some visible drop on the offshore side.

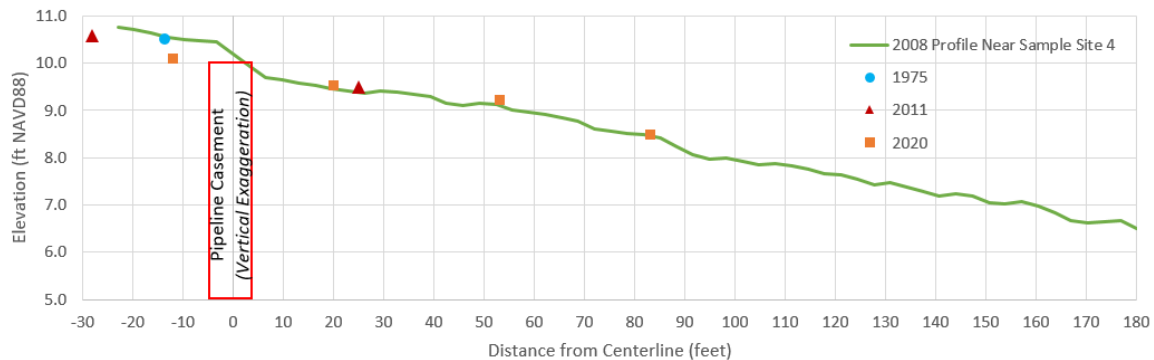
Figure 20 plots an example profile near Profile 4 where a change in elevation across the pipeline is evident from the high resolution 2008 survey. The elevations of the pipeline casement are approximate and are shown vertically exaggerated on Figure 20. Elevations shoreside of the lake line have been relatively consistent since 1975 (within the range of uncertainty described in Section 4.3). A small step down occurs to the offshore side of the casement in the 2008 profile. Note that most of the profiles across the study area in 2008 show no grade breaks near the pipeline.

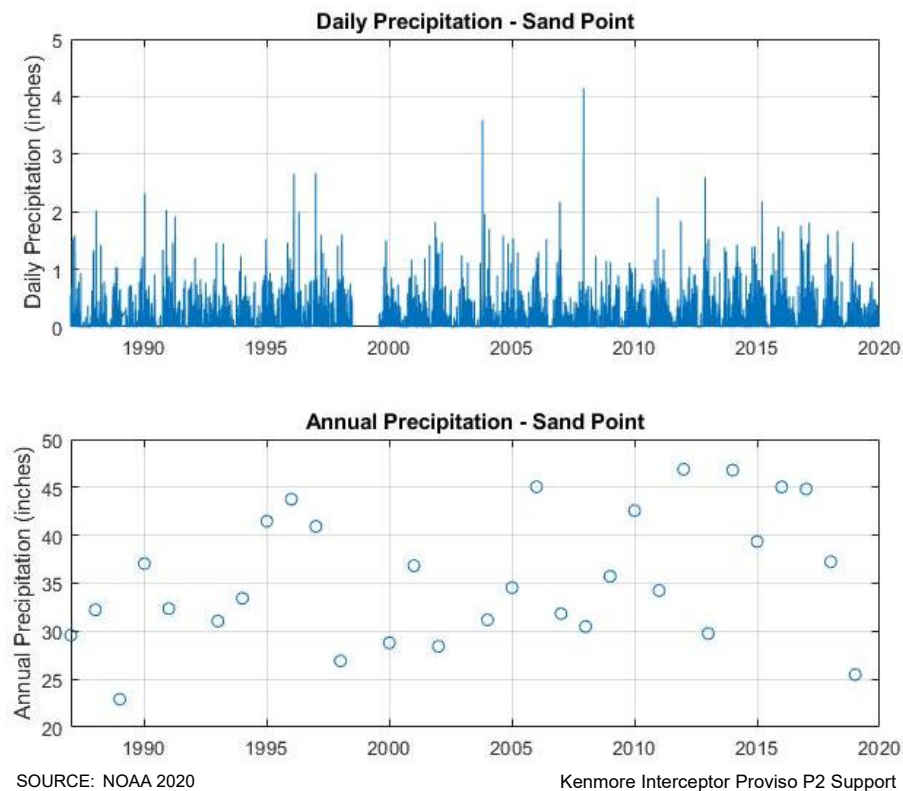
**Figure 21**  
Precipitation 1987–2019  
Sand Point

Figure 21 plots daily precipitation (top) and annual total precipitation (bottom) at Sand Point. No clear trends in precipitation occur from 1987 to 2020. The mid 2010s experienced several years of very high precipitation; however, interannual variability is high throughout the time period observed. Years of high precipitation may be correlated with increased streamflows and urban runoff directly into the lake from nearshore areas.

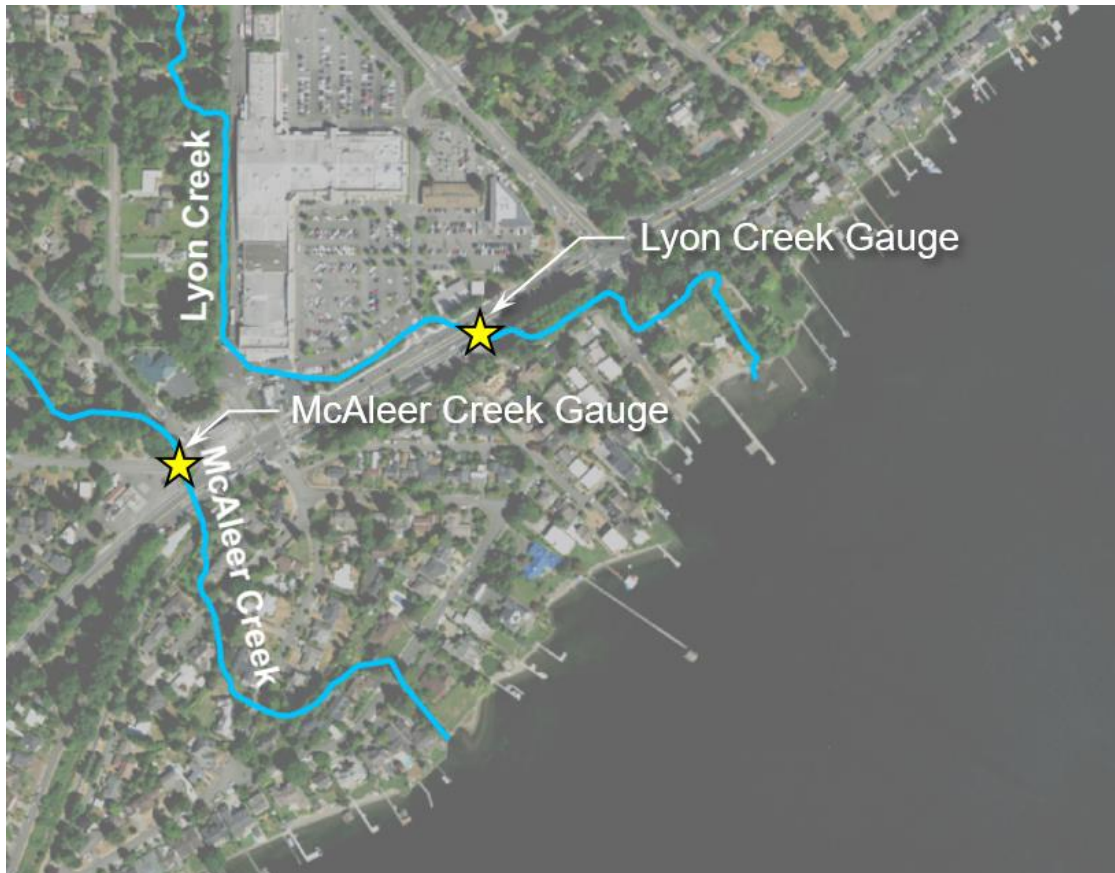
**Figure 22**  
Stream Gauge Locations

Streamflow and water quality parameters are monitored by the USGS and King County at stream gauges on Lyon and McAleer Creeks (Figure 22). A record of 15-minute streamflow is available for both creeks and is shown for each creek's respective length of record in Figure 23. Figure 24 summarizes the peak annual discharge in each stream.

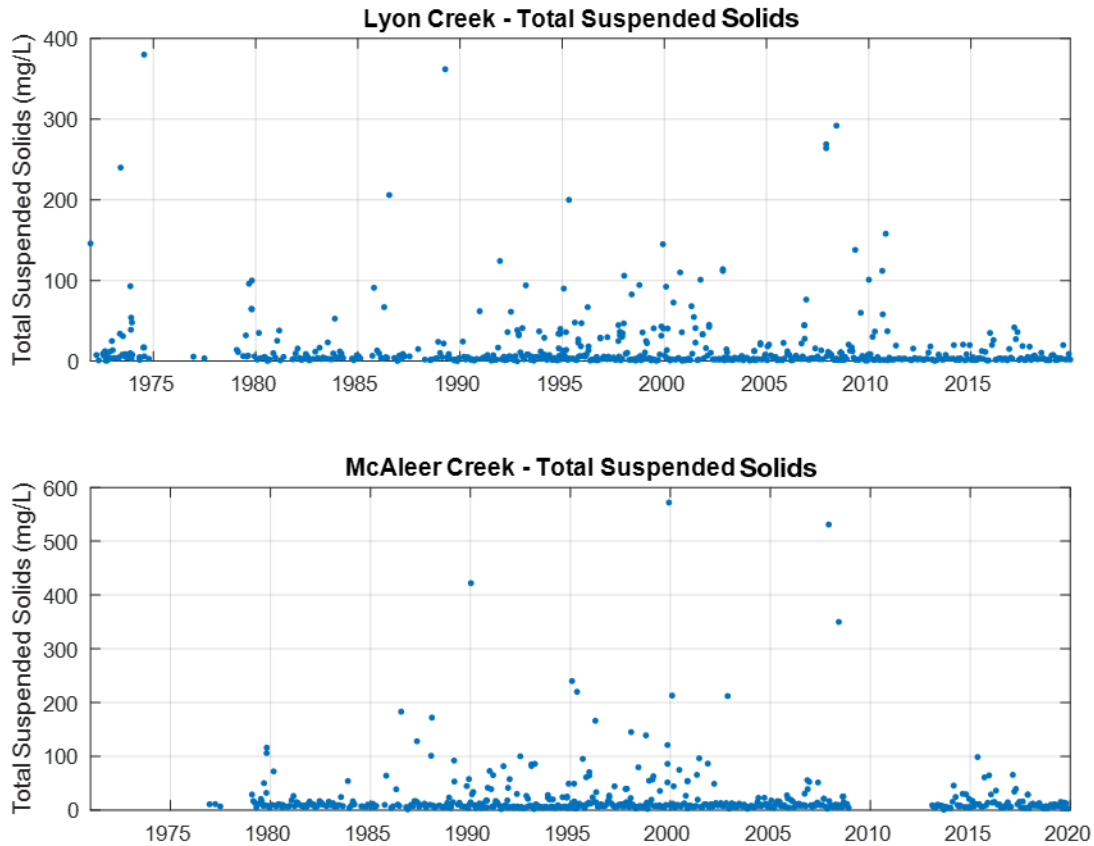
bedload (non-suspended). Figure 25 plots TSS for Lyon and McAleer Creeks from the 1970s to the present.

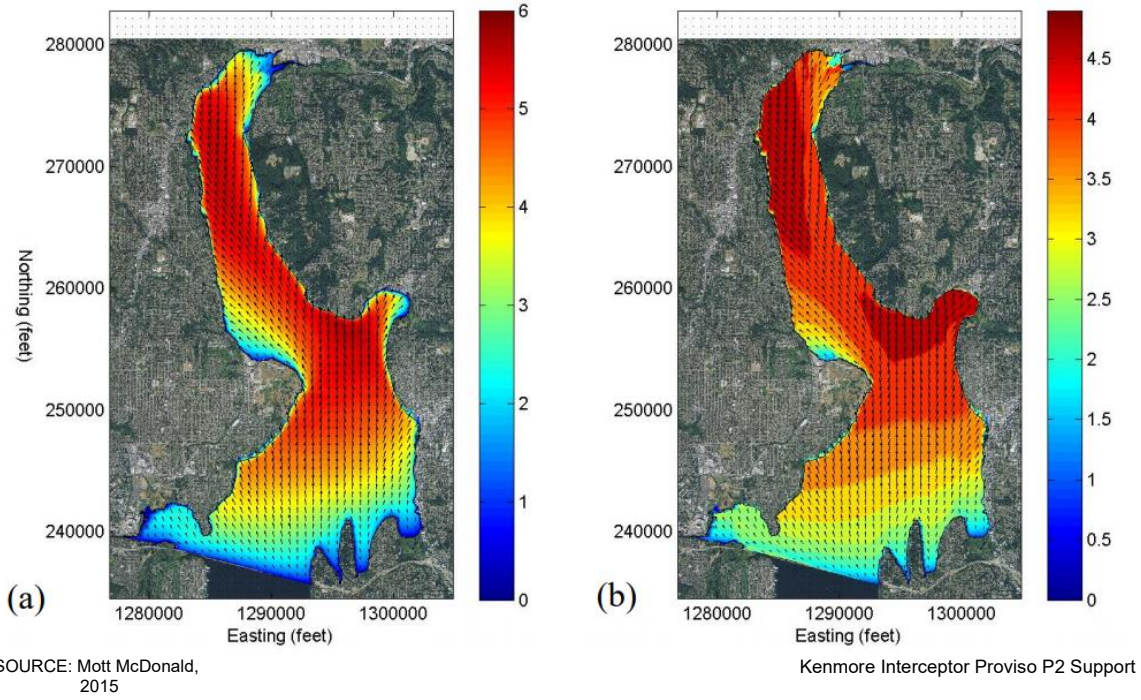
**Figure 29**  
Reproduction of Figure10 from Mott McDonald (2015)  
Wave Model Results for a 100-year Wind Storm from 170°  
Significant Wave Height (right) and Wave Period (left)

In addition to the information provided in SoundEarth and Lally (2011), Mott McDonald performed detailed wave modeling throughout Lake Washington on behalf of Washington Sea Grant and the City of Seattle in 2015. This work found that in the study area, a 100-year wind storm can generate waves with significant wave heights of approximately 5 feet and wave periods of 4.5 seconds (Figure 29, Mott McDonald 2015). Figure 30 shows the wave directions associated with the maximum nearshore wave heights over a series of model runs from the Mott McDonald report. Modeling confirms that in the study area, the nearshore wave directions associated with large waves from the south approach the shore in a northerly direction.

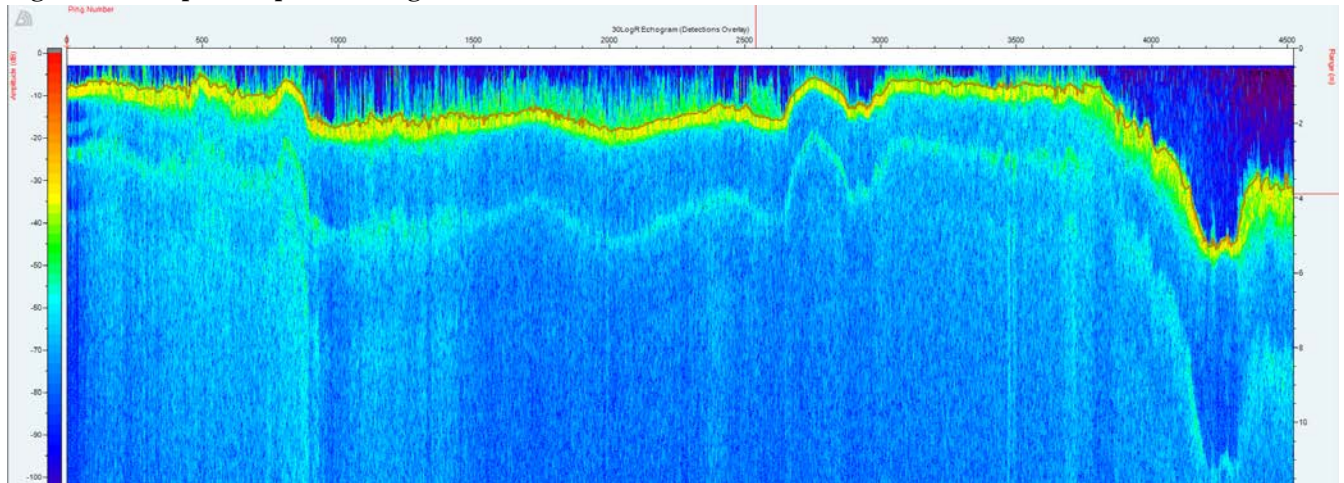
Figure 2. Example interpreted echogram

The solid brown line in Figure 2 indicates the interpreted mudline of the lake bottom in contrast to the water column (dark blue) and aquatic vegetation (turquoise). This is done by contrasting the return amplitude of the acoustic beam received by the sonar system. Typically, the strongest return (yellow-red) is the area where the density gradient is the greatest, such as the interface between water and sediment.
